Section IV. ORGANIZATIONAL TROUBLESHOOTING PROCEDURES

4-8. GENERAL.

a. This section provides information for identifying and correcting malfunctions which may develop when operating or maintaining the PGS.

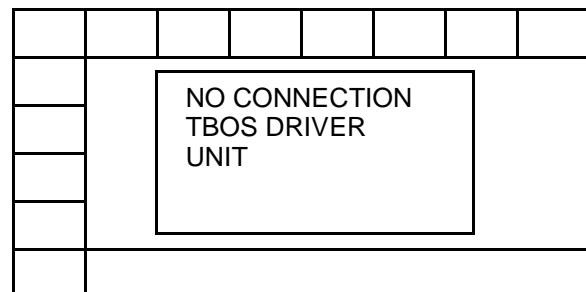
**1. CONTROL PANEL DISPLAY SCREEN SHOWS
“NO CONNECTION TBOS DRIVER UNIT”.**

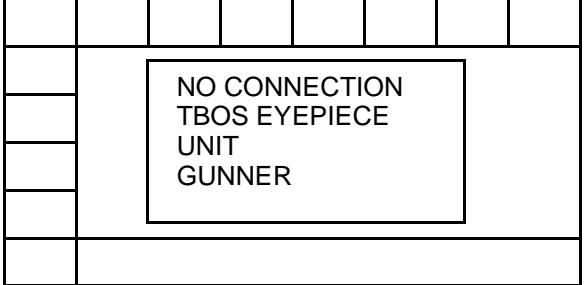
1. CONTROL PANEL DISPLAY SCREEN SHOWS “NO CONNECTION TBOS EYEPIECE UNIT GUNNER”.		
	NOTE	
Manual BIT and alignment proce- dures must be performed after each corrective action (see paragraphs 2- 6 and 2-7). Ensure that PGS is func- tioning properly before leaving vehicle.

A graphic of a control panel display with a 4x7 grid of small squares. In the center, there is a larger rectangular box containing the text "NO CONNECTION TBOS EYEPIECE UNIT GUNNER".
		Step 1. Replace W9 cable (see paragraph 4-34).
		Step 1. Replace TBOS gunner's eyepiece unit (see paragraph 4-15).
		Step 1. Replace TBOS driver unit (see paragraph 4-18).
		Step 1. Notify CLS.

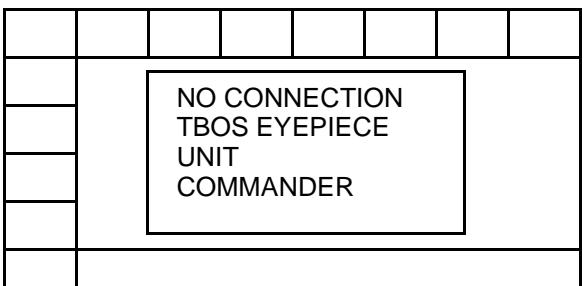
1. CONTROL PANEL DISPLAY SCREEN SHOWS “NO CONNECTION TBOS EYEPIECE UNIT COMMANDER”.		
	NOTE	
Manual BIT and alignment proce- dures must be performed after each corrective action (see paragraphs 2- 6 and 2-7). Ensure that PGS is func- tioning properly before leaving vehicle.

A graphic of a control panel display with a 4x7 grid of small squares. In the center, there is a larger rectangular box containing the text "NO CONNECTION TBOS EYEPIECE UNIT COMMANDER".
		Step 1. Replace W10 cable (see paragraph 4-35).
		Step 1. Replace TBOS commander's eyepiece unit (see paragraph 4-16).
		Step 1. Replace TBOS driver unit (see paragraph 4-18).
		Step 1. Notify CLS.

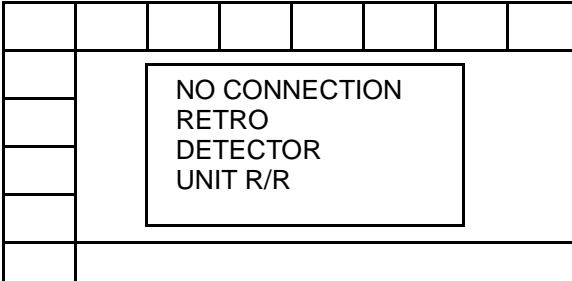
MALFUNCTION																									
TEST OR INSPECTION																									
CORRECTIVE ACTION																									
1. CONTROL PANEL DISPLAY SCREEN SHOWS "NO CONNECTION RETRO DETECTOR UNIT R/R".																									
NOTE																									
Manual BIT and alignment procedures must be performed after each corrective action (see paragraphs 2-6 and 2-7). Ensure that PGS is functioning properly before leaving vehicle.

<table border="1" style="margin-left: auto; margin-right: auto;"> <tr><td></td><td></td><td></td><td></td><td></td><td></td><td></td><td></td></tr> <tr><td></td><td colspan="7" style="text-align: center;">NO CONNECTION RETRO DETECTOR UNIT R/R</td></tr> <tr><td></td><td></td><td></td><td></td><td></td><td></td><td></td><td></td></tr> </table>										NO CONNECTION RETRO DETECTOR UNIT R/R														
	NO CONNECTION RETRO DETECTOR UNIT R/R																								
Step 1. Replace right-rear retro detector unit (see paragraph 4-14).

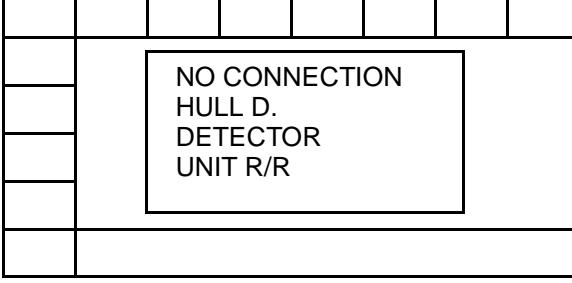
1. CONTROL PANEL DISPLAY SCREEN SHOWS "NO CONNECTION HULL D. DETECTOR UNIT R/R".																									
NOTE																									
Manual BIT and alignment procedures must be performed after each corrective action (see paragraphs 2-6 and 2-7). Ensure that PGS is functioning properly before leaving vehicle.

<table border="1" style="margin-left: auto; margin-right: auto;"> <tr><td></td><td></td><td></td><td></td><td></td><td></td><td></td><td></td></tr> <tr><td></td><td colspan="7" style="text-align: center;">NO CONNECTION HULL D. DETECTOR UNIT R/R</td></tr> <tr><td></td><td></td><td></td><td></td><td></td><td></td><td></td><td></td></tr> </table>										NO CONNECTION HULL D. DETECTOR UNIT R/R														
	NO CONNECTION HULL D. DETECTOR UNIT R/R																								
Step 1. Replace right-rear hull defilade detector unit (see paragraph 4-14).																									
Step 1. Replace right-rear retro detector unit (see paragraph 4-14).

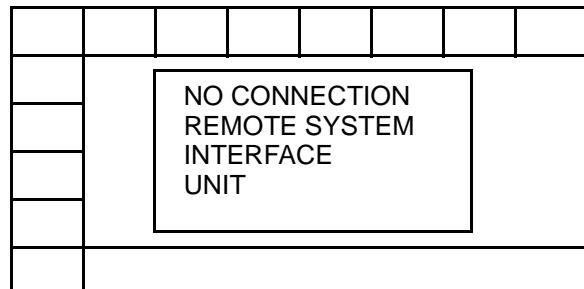
1. CONTROL PANEL DISPLAY SCREEN SHOWS “NO CONNECTION REMOTE SYSTEM INTERFACE UNIT”.

NOTE	
	Manual BIT and alignment procedures must be performed after each corrective action (see paragraphs 2-6 and 2-7). Ensure that PGS is functioning properly before leaving vehicle.	
		Step 1. Replace W1 cable (see paragraph 4-26).
		Step 1. Replace W2 cable (see paragraph 4-27).
		Step 1. Replace W3 cable (see paragraph 4-28).
		Step 1. Replace W4 cable (see paragraph 4-29).
		Step 1. Replace W5 cable (see paragraph 4-30).
		Step 1. Replace RSI unit (see paragraph 4-21).
		Step 1. Notify CLS.

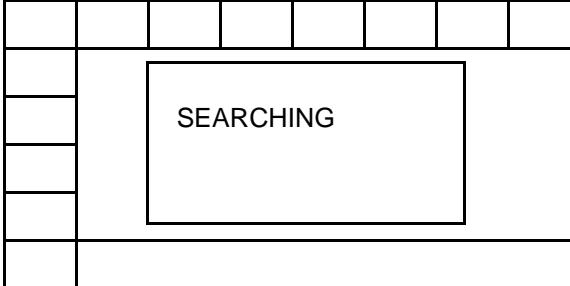
1. CONTROL PANEL DISPLAY SCREEN INDICATES “SEARCHING”.	NOTE

<p>The diagram shows a rectangular display screen with the word "SEARCHING" centered in a large white box. Above the screen, there is a horizontal row of seven smaller boxes, each containing a vertical line, representing a header or menu bar. Below the screen, there is a larger box representing the main content area.</p>
		<ul style="list-style-type: none"> • Manual BIT and alignment procedures must be performed after each corrective action (see paragraphs 2-6 and 2-7). Ensure that PGS is functioning properly before leaving vehicle. • “SEARCHING” is not a pop-up screen.
		Step 1. Replace RSI unit (see paragraph 4-21).
		Step 1. Replace RSI antenna (see paragraph 4-13).
		Step 1. Notify CLS.

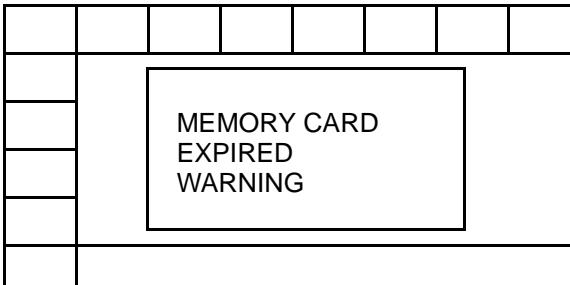
1. CONTROL PANEL DISPLAY SCREEN INDICATES “MEMORY CARD EXPIRED WARNING”.	NOTE

<p>The diagram shows a rectangular display screen with the text "MEMORY CARD EXPIRED WARNING" centered in a large white box. Above the screen, there is a horizontal row of seven smaller boxes, each containing a vertical line, representing a header or menu bar. Below the screen, there is a larger box representing the main content area.</p>
		<p>This malfunction indicates that the memory card is full.</p>

Either download TDRS memory card to TDRS computer unit and reprogram card or insert a new TDRS memory card.
